**Reference Information:**

OEM PN: 13R551  
 OEM Yield: 18,000  
 @ 5% page coverage

## Drum Unit Disassembly

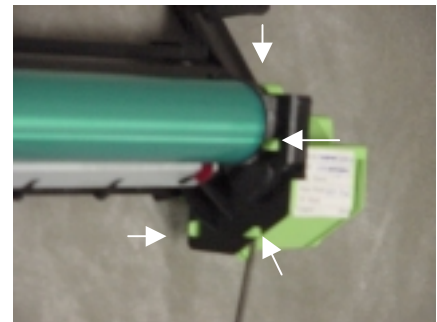
**Fig. 1**

1. Four locking tabs secure the gear cap to the drum unit (Fig.1). Squeeze the cap and use a flat head screwdriver to release the locking tabs. Remove the cap and set aside.

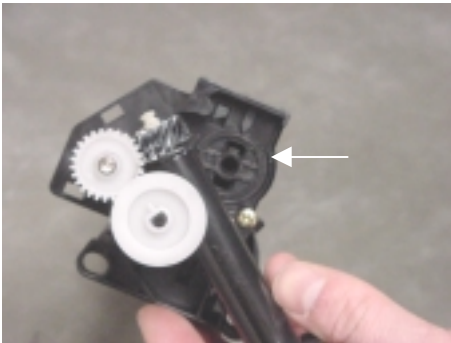
**Fig. 2**

2. The drum axle (Fig. 2) is in a locked position and is seated flush to the drum housing. Using needle nose pliers, rotate the axle counter clockwise a quarter turn to release the axle from its locked position. Remove the axle and carefully remove the drum.

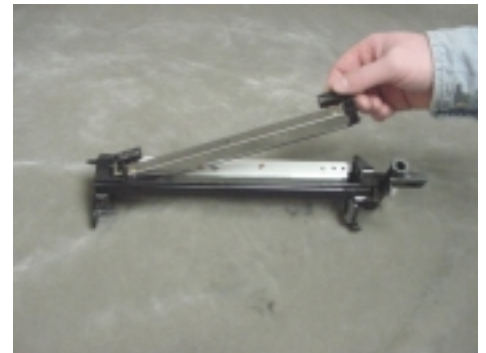
**Fig. 4**

5. Remove the two screws that hold the wiper blade in place (Fig.4). Remove the blade (Fig. 5) and clean with compressed air. Clean the waste bin with compressed air.
