OEM PN: 6R914
 OEM Yield: 6,000
 @ 5% coverage

Toner Unit Disassembly

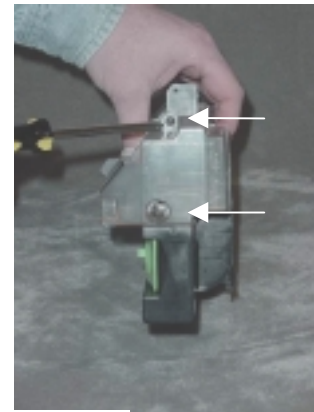
Fig. 1

1. Remove two screws that connect the waste bin to the toner hopper shown in Fig. 1.

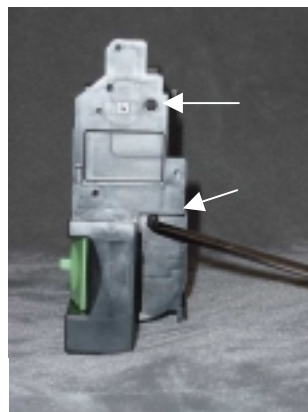
Fig. 3

3. Remove The two screws that secure the end cap to the toner hopper (Fig. 3).

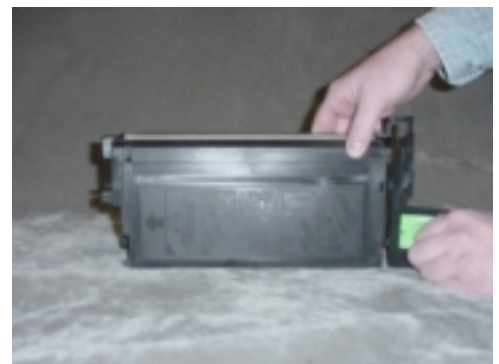
4. Pull the end cap toward the front of the hopper. There are two locking clips that will release and allow you to remove the end cap.

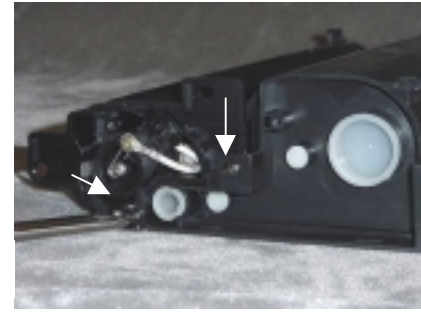
Fig. 5

5. Remove two screws that connect the developer section to the toner hopper shown in Figure 5.

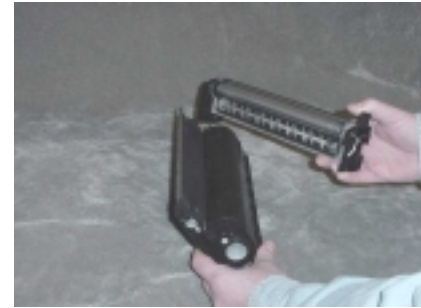
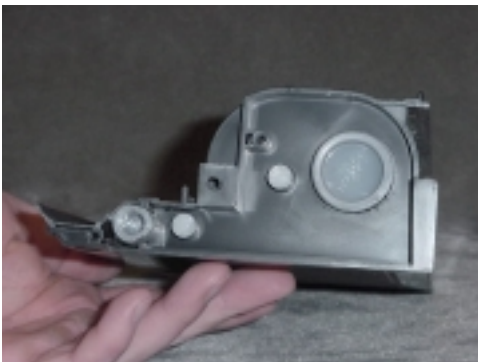
6. Once the screws are removed, separate the two halves by pulling the developer section away from the toner hopper.

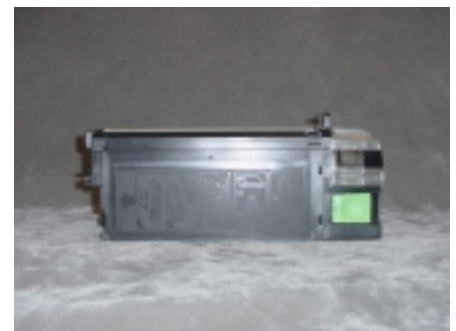
8. Reassemble the cartridge in reverse order to insure proper assembly.
